PORSCHE

928

32V'r V1 INSTRUCTIONS

32V'r - V1

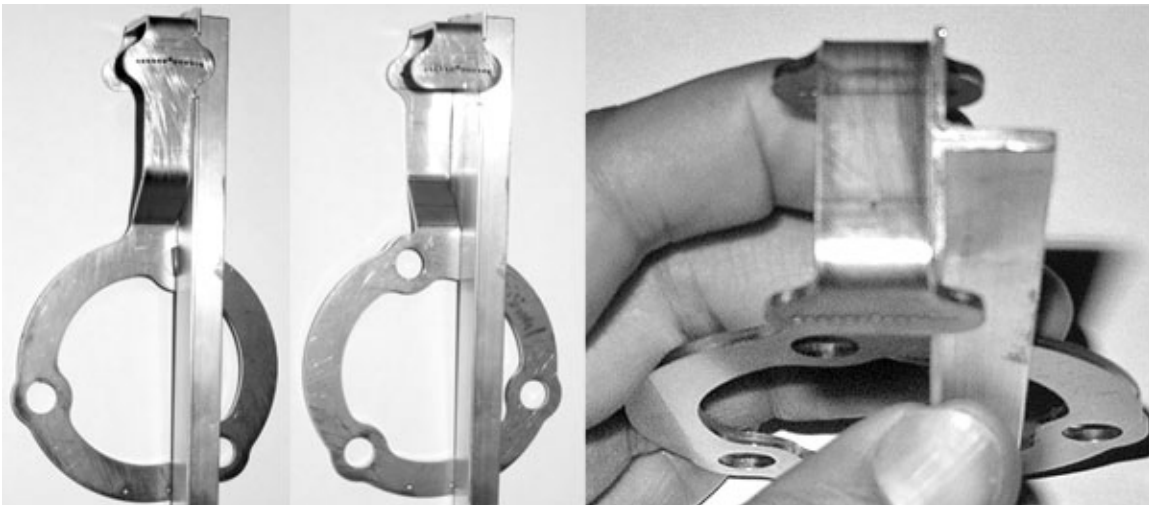
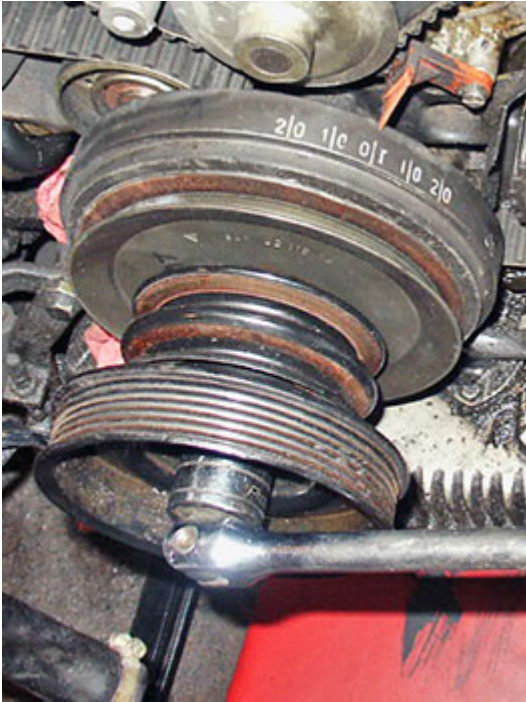
Alignment

Hold alignment bar tightly against both ends of the arm, and the ring. Note the position where the bar crosses the alignment hole in the ring. Flip tool over, and check again. Ideally, each side will reveal the same amount of alignment hole. If the reveal is larger on one side, clamp the arm in a vice, and gently pull or push the ring to even the reveal. Very slight movement is all that is needed. Check for twist in the arm as shown. Roll the needles along a flat surface to check for flatness. Use finger pressure to gently straighten them if necessary.

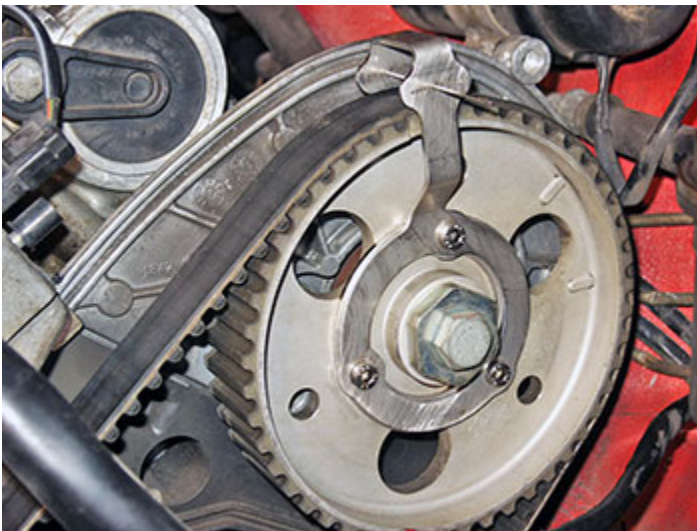
Slip 32V'r over clamp ring bolts.

Insert needle into hole that most closely fits into the housing indentation **V**.

Each hole is two crank degrees. Left of zero is advance, right retard.

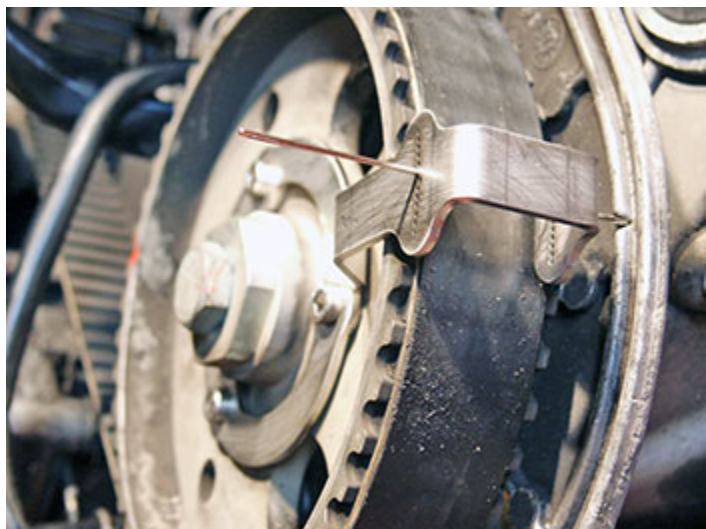
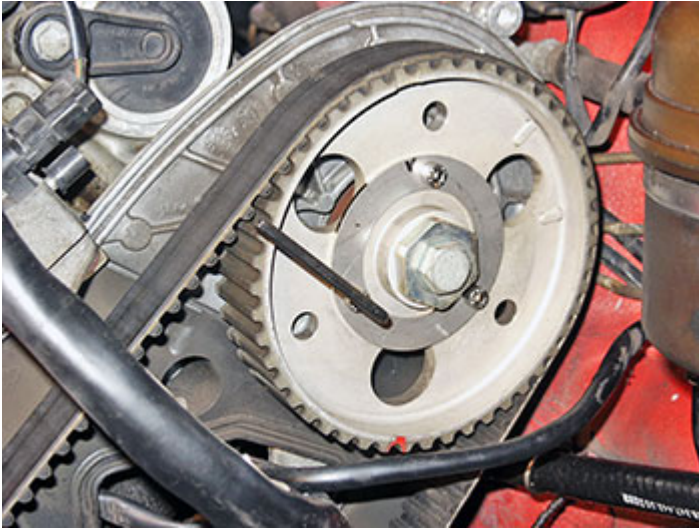
It is possible that the needle will not rest in the absolute center of the **V**.

Use two needles to split the difference, or use one needle, and swap in between two adjacent holes, for one degree.

Tighten clamp ring bolts.

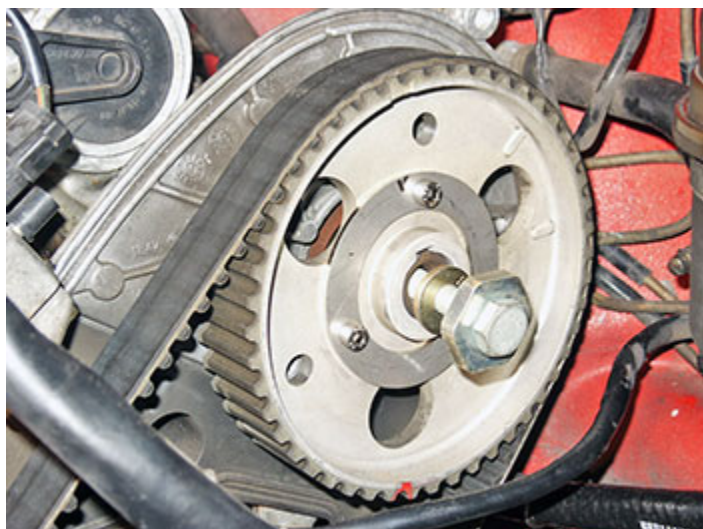
Counter hold cam bolt washer and loosen cam bolt.

Reinstall cam bolt with spacer.

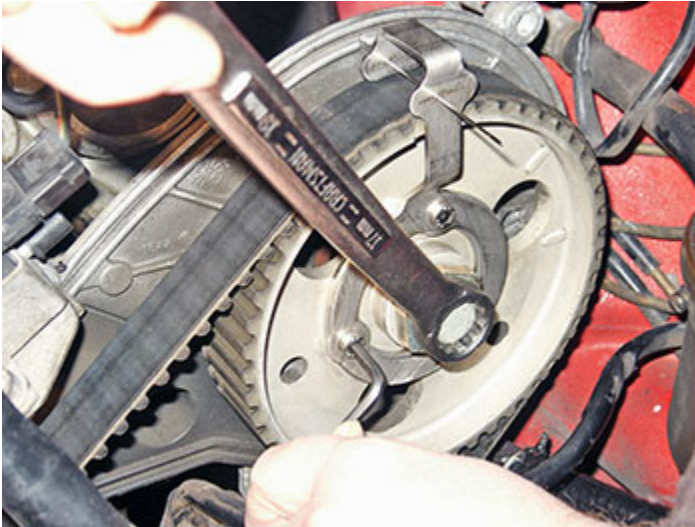
Counter hold cam bolt washer, tighten cam bolt to specification using torque wrench.

For advancing, or clockwise adjustment, slide indicator into the hole that corresponds to the amount of advance desired, with crankshaft at #1 TDC.

Loosen the clamp ring bolts and using a wrench on the cam bolt, rotate the cam bolt clockwise until the needle rests in the **V**.

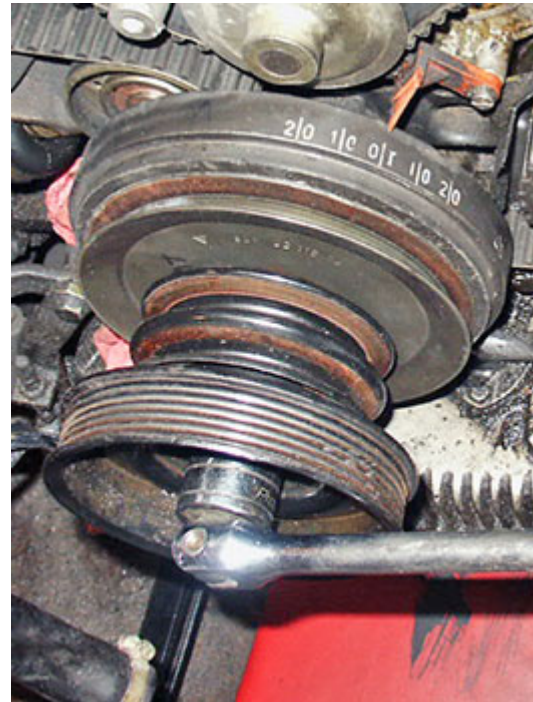
Loosen the clamp ring bolts, and while holding the cam bolt with a wrench, rotate the engine clockwise to #1 TDC.

While still holding cam bolt with wrench, tighten clamp ring bolts. Remove 32V'r.
