PORSCHE

928

32V'r V1 INSTRUCTIONS

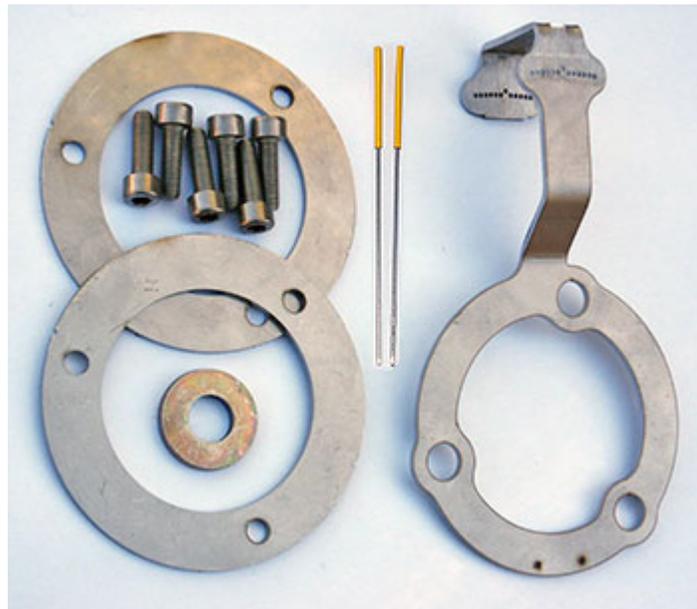
Each hole is two crank degrees. The center, raised hole is zero.

When looking at installed tool, counterclockwise/left of zero hole is advance, clockwise/right is retard.

A good basic setting (=factory zero), measured with a cold engine, is 1-4: 0°, 5-8: +2°. *The difference on the 1-4 side is to compensate for engine expansion when warm*

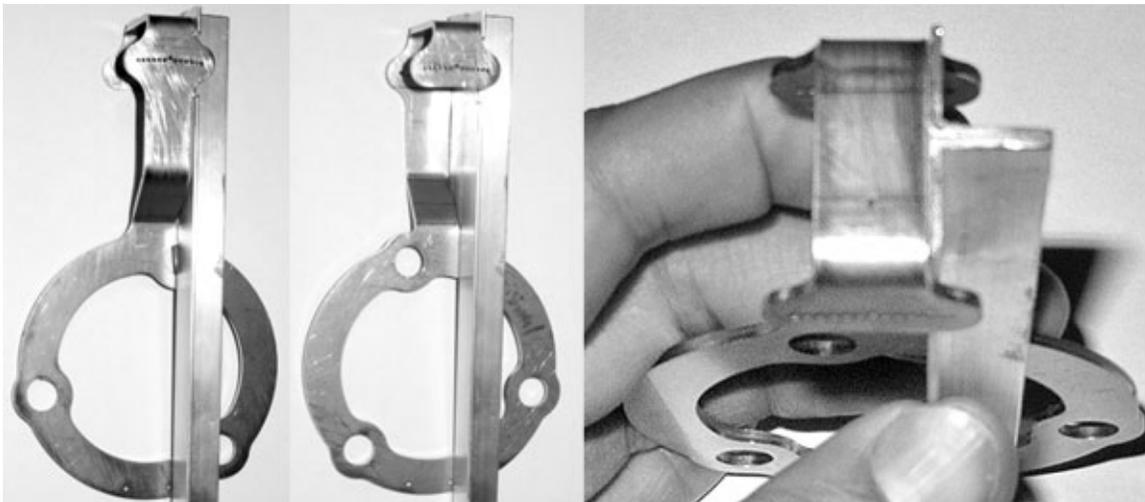
Hold alignment bar tightly against both ends of the arm, and the ring. Note the position where the bar crosses the alignment hole in the ring. Flip tool over, and check again. Ideally, each side will reveal the same amount of alignment hole. If the reveal is larger on one side, clamp the arm in a vice, and gently pull or push the ring to even the reveal. Very slight movement is all that is needed. Check for twist in the arm as shown. Roll the needles along a flat surface to check for flatness. Use finger pressure to gently straighten them if necessary.

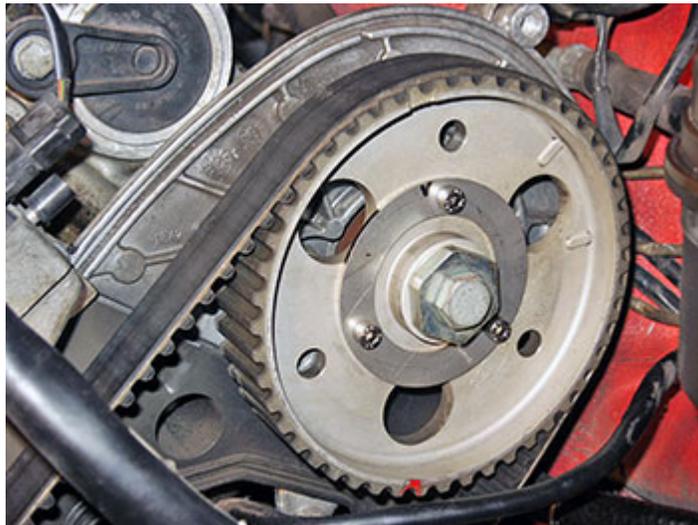
Install clamp rings with 5mm allen head bolts on both left and right cam gears.

One bolt is offset, so the clamp rings will fit in one position only.

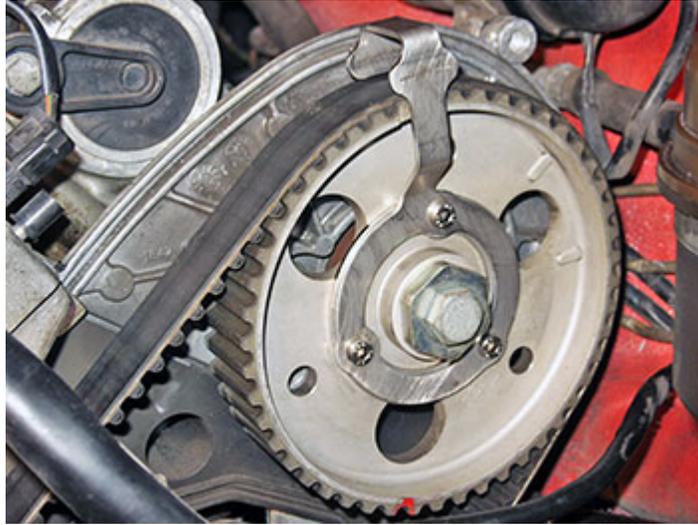
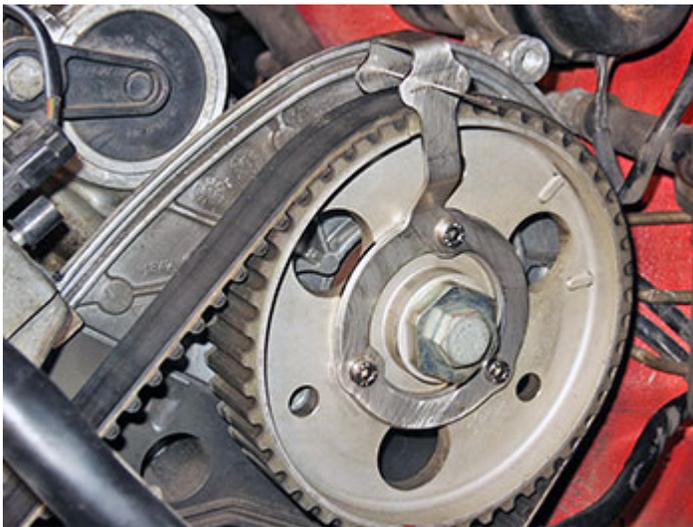
Slip 32V'r over clamp ring bolts.

Insert needle into hole that most closely fits into the housing indentation **V**.

Each hole is two crank degrees. Left of zero is advance, right retard.

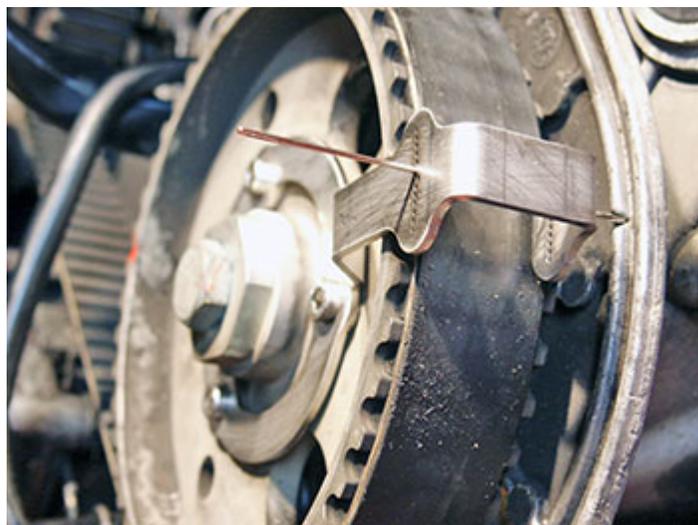
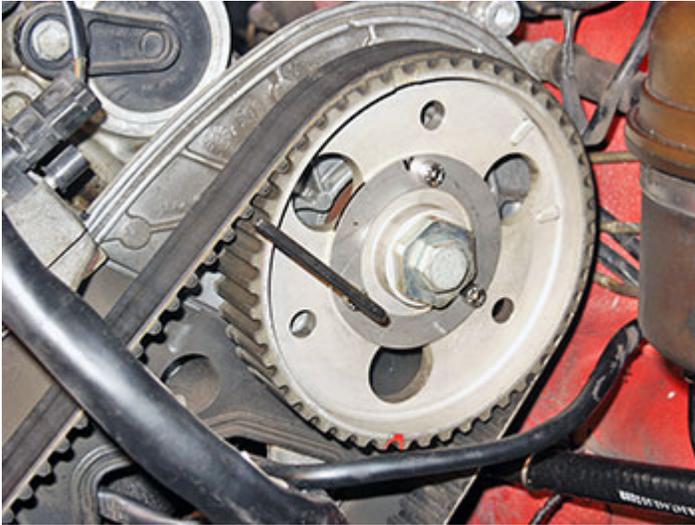
It is possible that the needle will not rest in the absolute center of the **V**.

Use two needles to split the difference, or use one needle, and swap in between two adjacent holes, for one degree.

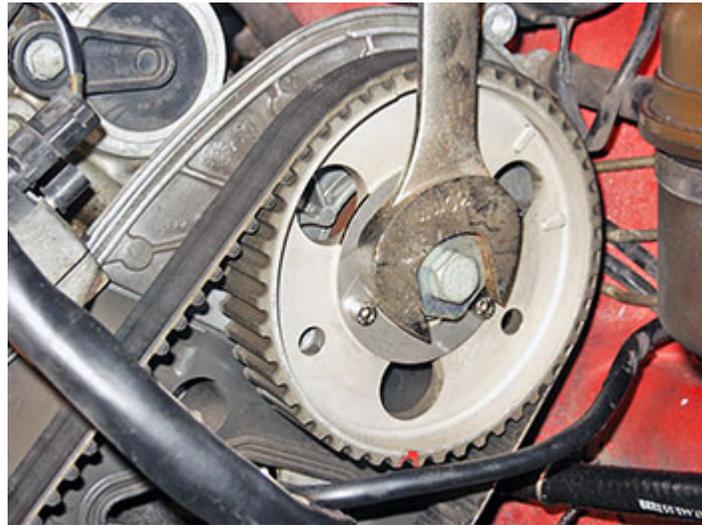
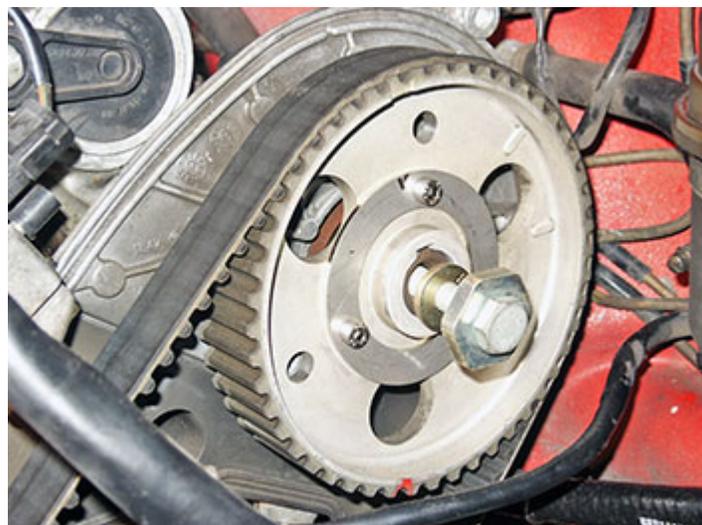
Tighten clamp ring bolts.

Counter hold cam bolt washer and loosen cam bolt.

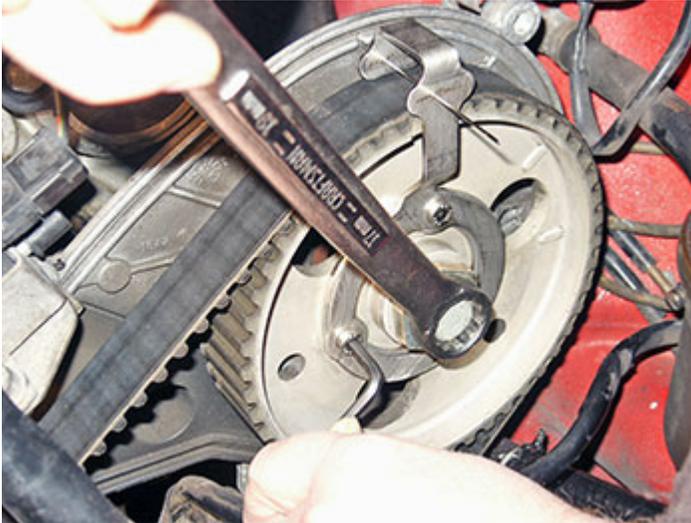
Reinstall cam bolt with spacer.

Counter hold cam bolt washer, tighten cam bolt to specification using torque wrench.

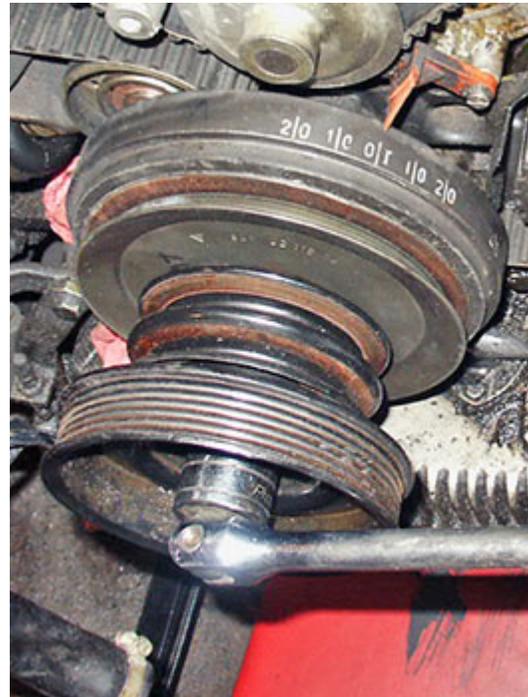
Loosen the clamp ring bolts, and while holding the cam bolt with a wrench, rotate the engine clockwise to #1 TDC.

While still holding cam bolt with wrench, tighten clamp ring bolts. Remove 32V'r.
